BELZONA PROTECTS COAL DRYER FAN

Eroded fan blades

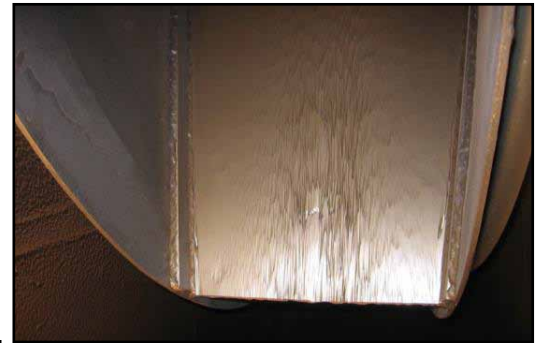
The fan blades were being eroded by the hot coal and water mixture under operating temperature of 110°C.

1. View of the wear pattern exhibited by the fan blades.
2. Preparation of the metal surfaces in progress via grit blasting.
3. Completed application. Eroded areas were rebuilt with Belzona 1311 and coated with Belzona 1391.
4. Condition of fan blades after 12 months in service.
