## COOLING SYSTEM EXPANSION JOINT PROTECTED WITH BELZONA

Eastern Oklahoma, USA

July 2017

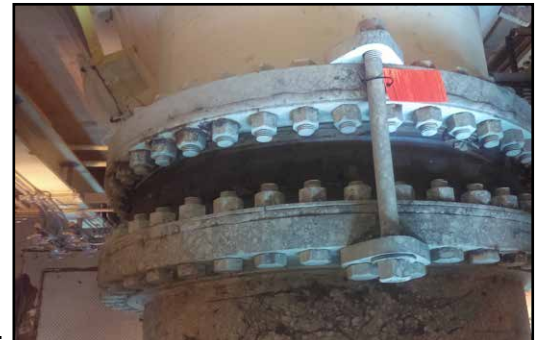
This coal-fired power plant uses river water pumped into several condensers to cool their turbines. There is a rubber expansion joint between the 52" inlet pipe and the condenser head. The cooling water flows through this system at low pressure, high volume.

1. The joint is 52" diameter and 9" wide.
2. Damaged rubber exposes the steel mesh underneath.
3. The most severe damaged areas are patched with 2311 and 9341, after prepping and conditioning the surface.
4. The full surface of the joint is sealed with 2211 and 9341, followed by a coat of 2221.

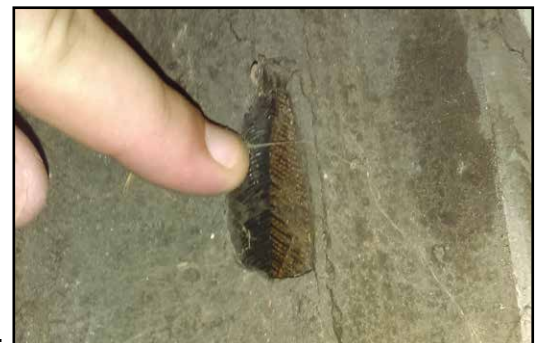
2.

The rubber joints are deteriorated and have developed slow leaks in a few spots. Replacement joints are very expensive and require an 8 week lead time to order. In the middle of summer, the plant has very limited ability to shut down for maintenance. The plant engineers were concerned that further damage to the joint could result in a blowout, causing massive flooding inside their facility and potentially overheating a turbine.
