BELZONA COLD PLATE BONDING AND TRADITIONAL COMPOSITE WRAP RESTORES DISCHARGE PIPE

Montana, USA

May 2017

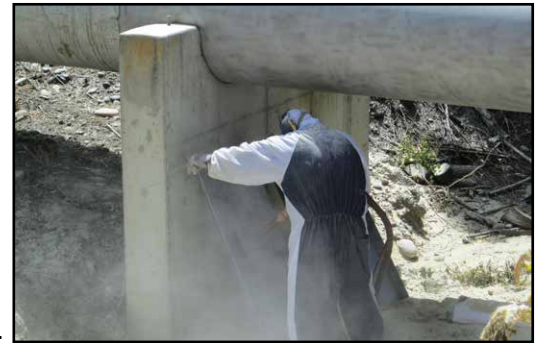
1. Surface preparation of saddle plates and pipe
2. Some of the numerous plates cold bonded in place
3. Second wrap of the composite repair prior to application of an UV protection third coat
4. 33 feet of pipe length completed and coated to withstand ultraviolet light exposure

A modified Belzona System Leaflet VPF-11 was used. The pipe was already riddled with large through-wall defects, and after abrasive blasting the pipe, numerous small holes developed. These small holes were repaired with Belzona 1111 reinforced with Belzona 9341. The larger holes were repaired using a plate cold bonding technique. The adhesive used was Belzona 1121 due to its extended working life. A two-wrap traditional composite system, consisting of Belzona 5811 reinforced with Belzona 9331, was applied. A third coat was used to fully encapsulate the reinforcement sheet. A final paint was used to prevent UV degradation.
