BELZONA REPAIRS A WIND TURBINE SHAFT

Wind Farm, Spain

May 2017

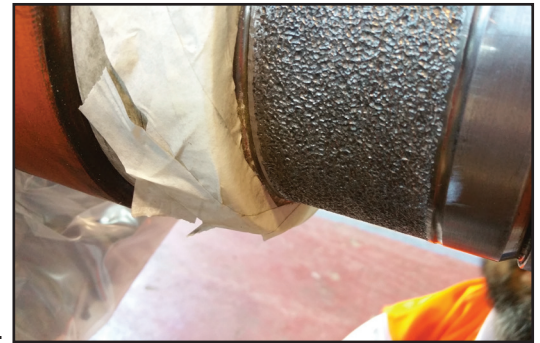
1. Shaft following surface preparation
2. Formers coated with release agent
3. Injection of Belzona 1321 into the mould
4. Shaft rebuilt to exact dimensions

The applications were carried out in accordance with Belzona Know-How System Leaflet MPT-2. The surfaces were prepared using mechanical hand tools. The pre-designed moulds were coated in release agent in order to allow clean removal of the formers post cure. Belzona 1321 was used to wet out the surfaces of each shaft, prior to the installation of the formers and the injection of the paste-grade into the moulds. After 24 hours, the moulds were removed and the repairs were sanded to exact dimensions required.
