OFFSHORE DECK REPAIRED AND COATED WITH BELZONA PROTECTIVE SYSTEMS

APPLICATION SITUATION
Offshore Oil Platform Deck

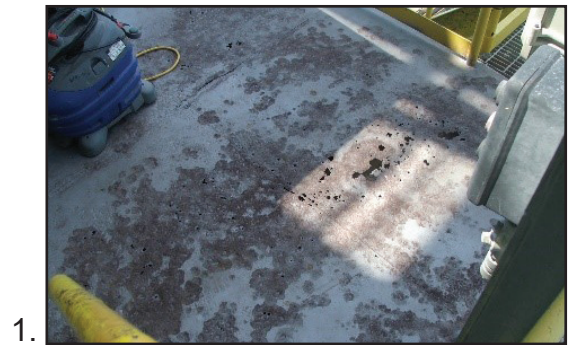
PROBLEM
The surface of the deck had become weak due to severe corrosion and metal loss of the platform deck.

- PICTURES**
1. Corrosion and through-wall holes in the deck
 2. Holes repaired with Belzona 1121
 3. Application of Belzona 5821 incorporating Belzona 9211
 4. Completed application of Belzona 5233, a UV stable top coat
