BELZONA REPAIRS CORRODED LIME TANK

Motor Manufacturer, Sunderland, UK

July 2017

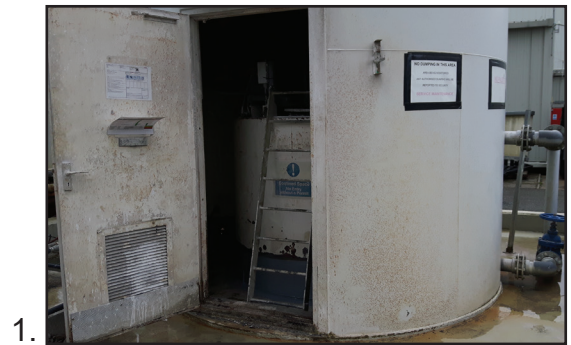
Customer had a 25 year old lime holding tank.

1. Lime Tank structure.
2. Corroded area detail.
3. Corroded area around the inner tank.
4. Finished application.

Application was carried out in accordance with a modified version of Belzona System Leaflet TCC-5. Corrosion along the base was removed via grit blasting then plates were bonded in place to reinforce the steel work. Belzona 5811 was then applied to protect against further corrosion.

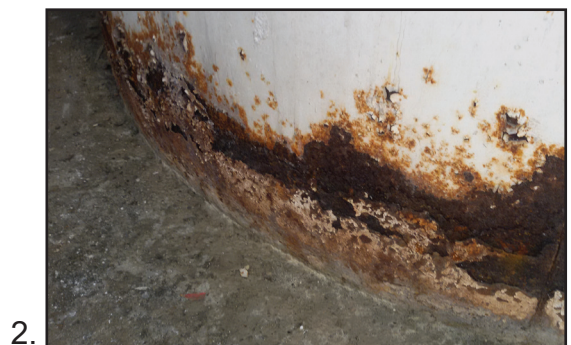
The tank was suffering from corrosion problems around the outer lower sections of the tank. In addition to this, there was also corrosion to the base of the smaller inner tank.
