## BELZONA PROTECTS THE SURFACE OF MAIN WATER-PUMP INLET MANIFOLD

Mining Company, Norway

September - October, 2017

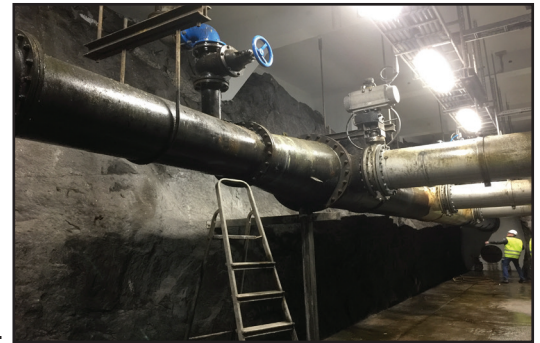
Severe corrosion on these pipes externals had developed over 50 years, several unsuccessful attempts to protect the pipe had been started and ended without fully protecting the surface over the last 10 years. Humidity of 100%, constant running water from the surface and no possibility to gritblast meant conditions were not ideal for a coating application.

1. Overview of wet and condensed pipe manifold.
2. Surface preparation and first coat application ongoing.
3. First coat applied.
4. Final coat applied and cured. Constant running water from the surface can be seen.
