BELZONA REPAIRS PIN BUSH HOUSING

Pin Bush Housing on mining power shovel.

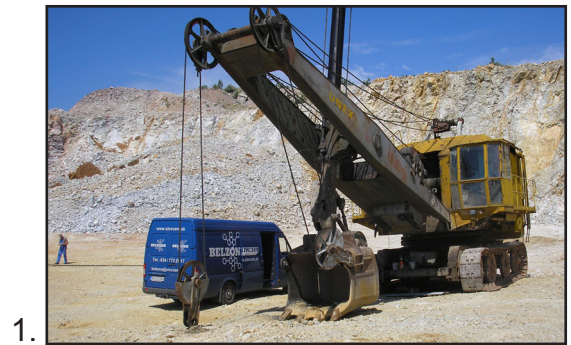
Housing had been damaged and worn down over time.

1. Mining Power Shovel.
2. Machining to proper diameter for Belzona 1111 application.
3. Bushing inserted.
4. Ready for service.
