## BELZONA REPAIRS 82 EXPANSION JOINTS ON A PRIMARY SETTLEMENT TANK

**CUSTOMER**  
Bedford, UK

**APPLICATION DATE**  
August 2017

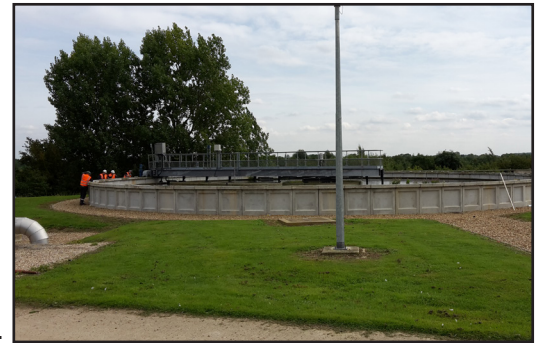
**APPLICATION SITUATION**  
The customer's Primary Settlement Tank was unable to operate efficiently and the tank's arm was struggling to rotate, which could have caused further damage to the equipment.

- PICTURES**
1. The settlement tank.
  2. A damaged expansion joint.
  3. Nosings rebuilt using a former.
  4. Completed expansion joint.

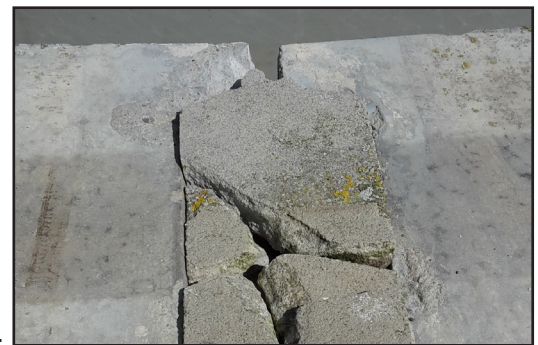
2.

**PROBLEM**  
Existing expansion joints had failed. The customer then tried to use a cementitious material to repair them but this also cracked and failed.

**BELZONA FACTS**  
The primary settlement tanks' original concrete design failed within four years due to water ingress. Belzona materials are resistant to this type of damage and so will last for many more years to come. This was one of the clients only options to keep the equipment in operation.
