BELZONA REPAIRS A FLOATING HOSE

Fuel transport hoses offshore

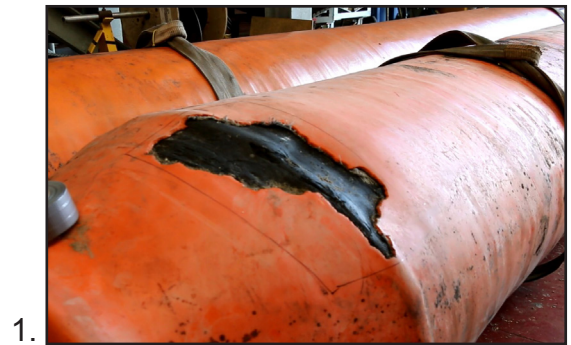
The rubber reinforced covers and flotation/insulation on fuel hoses was damaged. Thought to be caused by the ships propeller during fuel loading and unloading.

1. Damaged rubber.
2. Surface preparation.
3. Application in progress.
4. Finished application.
