BELZONA KEEPS THE COVER ON ANNEALING OVEN

Metallurgy Company, Slovakia

Large annealing oven at a metal manufacturing plant.

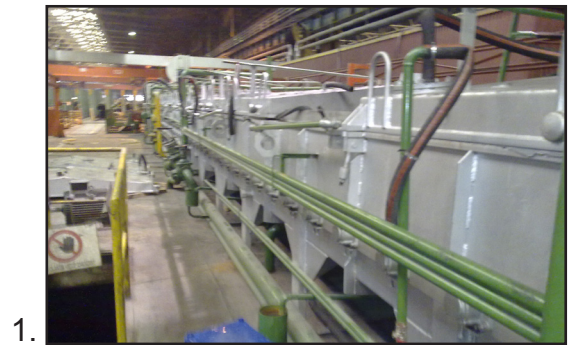
The cover had distorted and did not sit correctly on the base and caused a CO₂ leakage.

1. Annealing ovens.
2. Surface preparation.
3. Belzona 1121 application.
4. Cover replaced.
