BELZONA CREATES "SMOOTH RIDE" EXPANSION JOINT

North Carolina, USA

August 2016

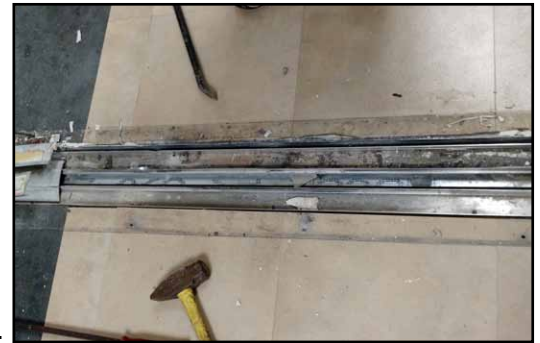
The hospital expansion joint had failed and the raised edge was presenting a trip hazard, as well as promoting the accumulation of dirt and residue.

1. Excavation of the damaged expansion joint
2. Concrete repaired around the expansion joint using Belzona 4111
3. Application of flexible Belzona 2211
4. Completed restoration of expansion joint

Application was carried out in accordance with Belzona System Leaflets FPA-5, FPA-6 and FPA-8. After excavating the original expansion joint the concrete nosings were rebuilt with Belzona 4111. After inserting backer rod into the joint, Belzona 4411 incorporating aggregate was applied over the surface of the Belzona 4111 to provide a slip reduction system either side of the expansion joint. Finally, Belzona 2211 was used to fill joint itself to create a highly elastic seal.
