## BELZONA PROTECTS SCREW AUGER FROM ABRASION AND CHEMICAL ATTACK

Screw Auger

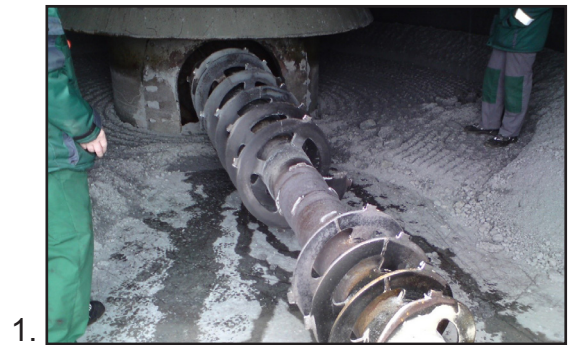
1. Before the application.
2. Before the application (close up).
3. After the application.
4. 8 years later.

After surface preparation, Belzona 1811 was applied to protect against abrasive attack and Belzona 4311 to protect against chemical attack.
