BELZONA WEATHERPROOFS THE ROOF AND SAVES ELECTRICAL EQUIPMENT ON OFFSHORE PLATFORM

Metal building with leaking roof on offshore platform. Electrical equipment housings inside building are getting corrosion damage.

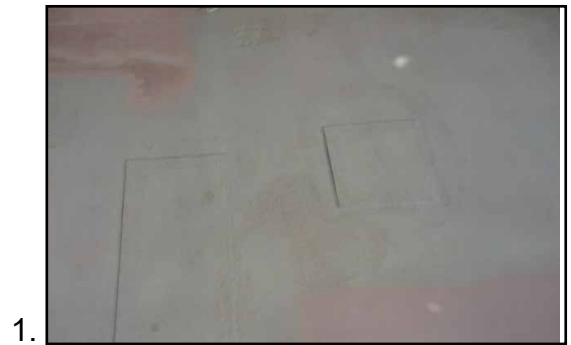
Water leaking into a metal building from existing patches on the roof and porous weld seams. Other types of epoxy repairs were tried, but failed due to the harsh offshore weather.

1. After abrasive blasting some metal patches were loose.
2. Metal plate perimeter and holes sealed with 1121.
3. Spray application of 5811 beige and non-skid aggregate.
4. Spray application of 5111 gray top coat.

Belzona 1121 is used to seal porous welds and fill gaps in existing welded metal patches. Belzona 5811 is used to seal all surfaces. Belzona 5111 is used as a top coat to provide durable weather resistance.
