BELZONA REPAIRS AND COATS END SUCTION PUMP CASING

Centrifugal pump at a papermill.

The casing was badly damaged and cracked.

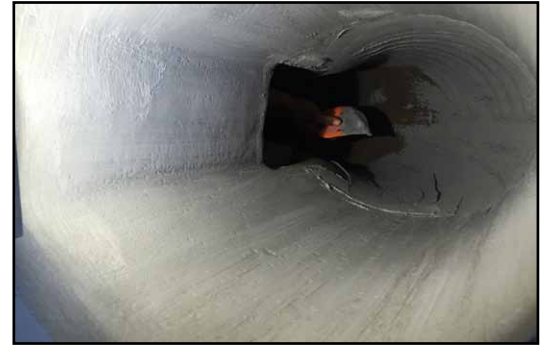
1. Installing Belzona 1121 to fill in pits and form a smooth uniform surface
2. First coat of Belzona 5821 applied at 10 mils
3. Second coat of Belzona 5821 being applied at 10 mils
4. Two coats of Belzona 5821, total DFT of 20 mils

Surface was abrasive blasted to a cleanliness standard of SSPC-SP10 and a minimum of a 3 mil angular profile on internal wet area. Internal pitting and repair damage was filled with Belzona 1121. Two (2) coats of Belzona 5821 was applied at a minimum of 10 mils per coat on internal surfaces. Coated components were inspected and all holidays or imperfections were corrected. The application was carried out in accordance with Belzona Know-How System Leaflets CEP-3 and CEP-5.
