AN OLD STEEL TANK PUT BACK TO SERVICE WITH BELZONA

A neglected steel oil tank that needed to be put back into service.

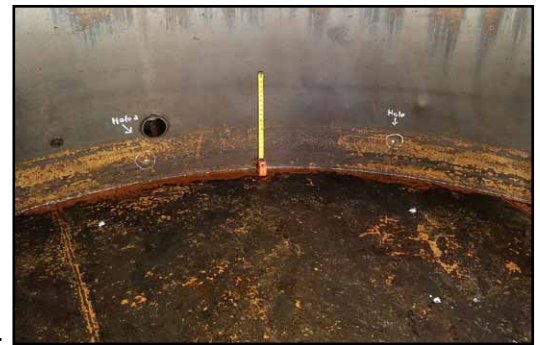
Hundreds of holes in the floor and 8" up walls of the interior of this bulk storage tank. Large holes were visible and straightforward to repair. Small holes and metal porosity plague the entire surface.

1. Hundreds of holes in tank floor and walls.
2. Process of Belzona 1121 composite repair and cold plate bonding on floor.
3. First coat Belzona 5811 Grey
4. Second coat Belzona 5811 Black
