BELZONA EXPANSION JOINTS A BETTER SOLUTION

Nashville Tennessee Convention Center

March 2016

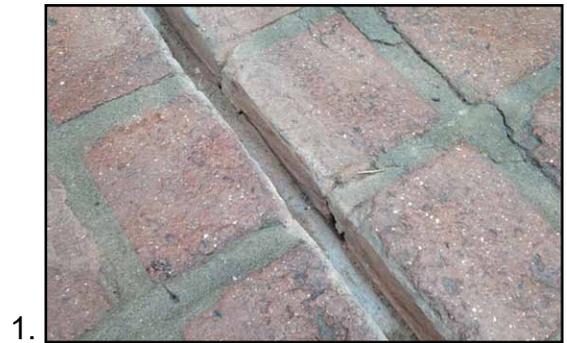
1. Joint edges ground and cleaned to remove old adhesives and loose material
2. Joint edges taped and conditioned
3. Application in process
4. Application completed

Application was carried out in accordance with Belzona System Leaflet FPA-6. Old caulk and filler material was removed and the joint edges were ground with a masonry disc to insure a bond to firm substrate. Loose material was cleaned away and a solvent wipe was used to remove dust. The edges of the joint were taped with gaffers tape to insure materials did not extend beyond the intended area of application. Backer rod was inserted into the gap and set at depth of 1/4". Belzona 2911 was used to condition the edges of the expansion joint. After allowing the Belzona 2911 to dry, Belzona 2211 was troweled into the joint, taking care to insure good contact at the edges of the joint. The joint was then allowed to cure before foot traffic was allowed to return to the surface. The joint application was split into two parts to allow pedestrian traffic to use one lane of the bridge during cure.
