BELZONA SHAFT REPAIR KEEPS THE CONVEYORS TURNING

A snack manufacturer was looking for a way to repair shafts rather than constantly replacing components.

A bearing had overheated and seized resulting in a worn area on the shaft.

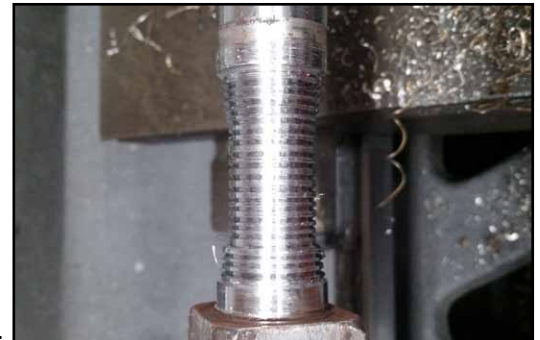
1. Shaft undercut and grooved in preparation for application
2. Belzona 1111 build up completed
3. Turning shaft back to original outer diameter
4. Application completed and perfectly fit to a new bearing

Application was carried out in accordance with Belzona System Leaflet MPT-1. Shaft was placed in a lathe and the damaged area was undercut and grooved to aid in mechanical bonding. Final cleaning was done using Belzona 9111 (Cleaner/Degreaser). Belzona 1111 was built up on the shaft, taking care to press it firmly into the grooves and avoid air entrapment. After approximately 90 minutes the shaft was turned on the lathe back to its original outer diameter and polished with emery cloth to create a perfect fit with a new bearing.
