BELZONA REPAIRS AND SAVES INTERNALS OF WASTEWATER PIPE

Water Treatment Plant, Bossier City, LA, USA

42" Ductile Iron underground pipe.

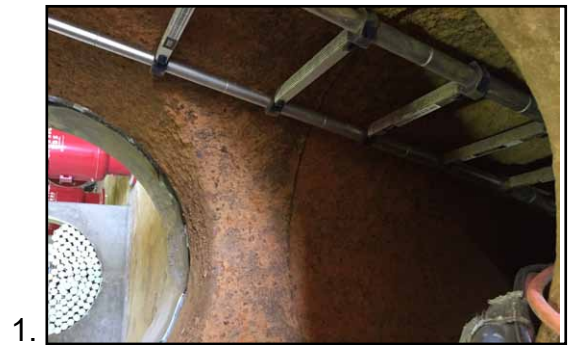
The pipe was corroded so badly that the pitting was causing pin holes in the substrate.

1. Corroded pipe before application.
2. Internals of pipe after SP-10 Abrasive Blast.
3. Applicators applying Belzona 1121 to pitting.
4. The pipe after being coated with Belzona 5811.
