RESEATING PIN BUSH WITH BELZONA ON CATERPILLAR 980 LOADER

Mine, Skopje, Macedonia

February 2017

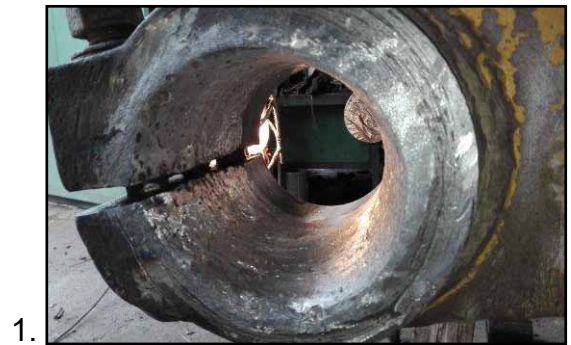
Lack of lubrication had caused abrasion in the bush housing, which led to a diameter increase of 30 mm from the original dimension. This meant a loose fitting bucket pin and unstable use of the equipment.

1. Damaged pin bush housing
2. New bushing installed with Belzona 1111
3. A dummy shaft was used to locate the bushing
4. View of Caterpillar 980 machine

Application was carried out in accordance with Belzona Know-How System leaflet MPT-8. The surface was prepared by grinding and a new bush was bonded into place using Belzona 1111. Other bushing was in a good condition. In order to ensure the bushes were in correct alignment a dummy shaft was used to locate the bushing.
