BELZONA MAKES QUICK WORK OF CLEAT REPAIR

A recycling facility needed a way to repair a torn cleat rather than replace the entire belt.

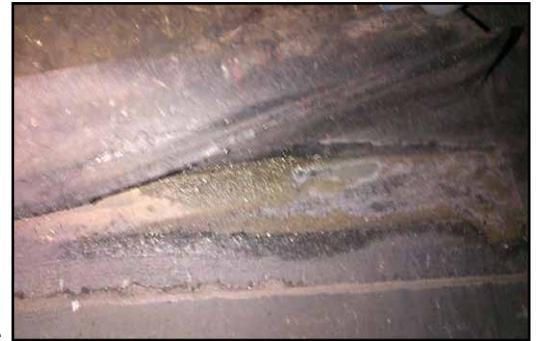
Cleat on conveyor belt used to sort materials at a recycling facility was torn and ineffective. The design of the equipment was allowing the conveyor to become clogged and putting more strain on the cleats than the original vulcanization could handle.

1. Damaged cleat
2. Repair area cleaned, roughened, and conditioned
3. Repair completed
4. Repair revisited 8 months later, still performing perfectly
