BELZONA REBUILDS SHAFT DURING WIND TURBINE MAINTENANCE

Wind farm, Central Sweden

May 2011

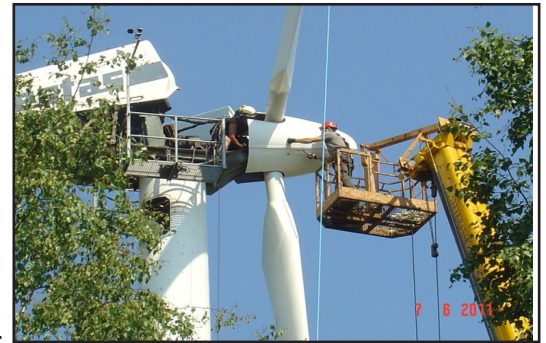
1. Crane access required to maintain the nacelle
2. Nacelle removed for routine inspection and maintenance
3. Corroded shaft
4. Shaft rebuilt using self-lubricating Belzona 1131

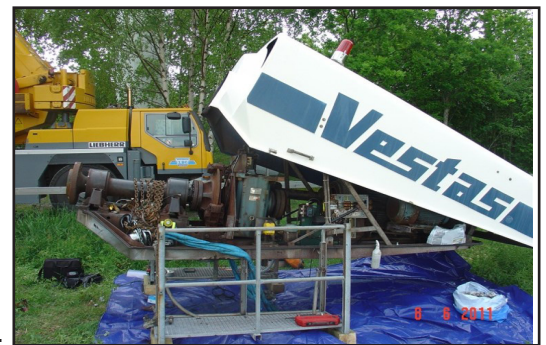
2.

During maintenance of the turbine at a small wind farm, the nacelle was removed in order to inspect the internal components.

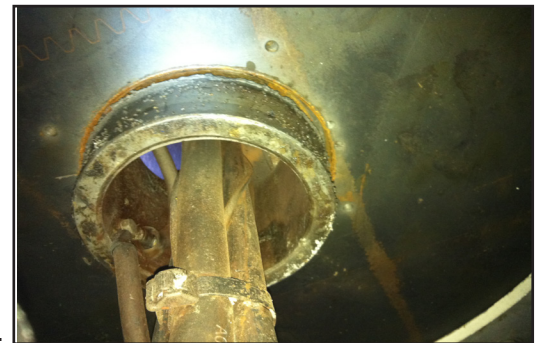
3.

Inspection revealed that the nacelle had suffered from water ingress and the yaw drive shaft was experiencing damage due to corrosion and wear due to lack of lubrication.
