## BELZONA RECOVERS CONCRETE CLEAR WELL AT A 50-YEAR-OLD WATER PLANT

Water Plant, Rural Oklahoma, USA

Concrete clear well.

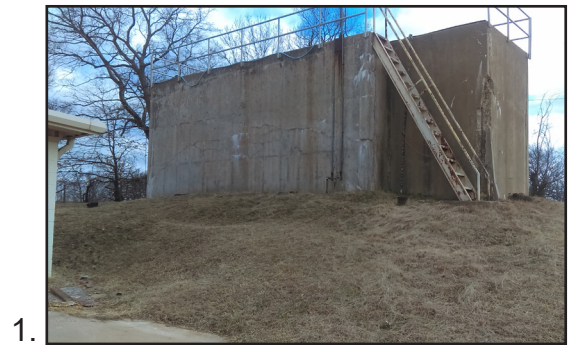
This concrete clear well had 185 linear feet of hairline cracks and corners that were gradually crumbling off as well as exposed rebar.

1. Hairline cracks on the exterior of the concrete wall
2. Concrete surface preparation
3. Injection ports anchored with Belzona 1121
4. Belzona 4141 application
