## BELZONA REPAIRS CRUSHER SHAFT

Cement plant, Northern Cape, South Africa

Crusher shaft

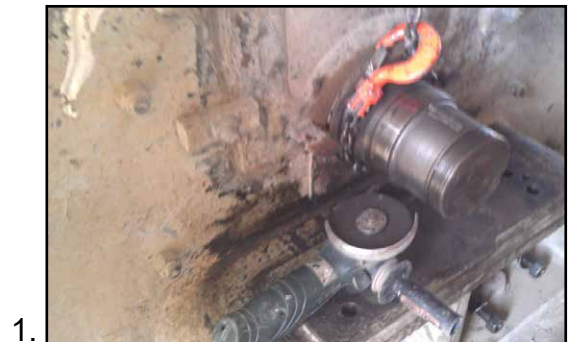
1. Shaft being prepared.
2. Roughened shaft being degreased with Belzona 9111
3. Belzona 1111 applied to shaft before former located
4. New bearing installed on the shaft

Application was carried out in accordance with Belzona System Leaflet MPT-2. A former was used to accurately rebuild bearing location on the shaft.
