BELZONA SUPERWRAP II SETS SAIL

A repair to a carbon steel boat hull using Belzona SuperWrap II patch repairs, plus a further coating of Belzona 1321.

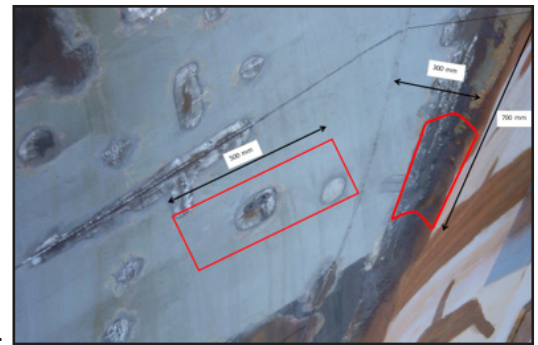
Loss of steel, leading to thin walling on the boat's hull. This damage has occurred due to corrosion within the marine environment. The asset owner was looking for a solution to reinstate the metal loss and provide long lasting protection against the harsh environment at sea.

1. Areas on the boat hull to be repaired.
2. Application areas prepared via abrasive blasting.
3. Belzona SuperWrap II patches applied.
4. Finished application coated with Belzona 1321.
