YACHT SEA CHEST TUBES FLANGE FACE REBUILT AND COATED WITH BELZONA 1111 AND 1331

CUSTOMER
Florida, USA

APPLICATION DATE
Fall 2017

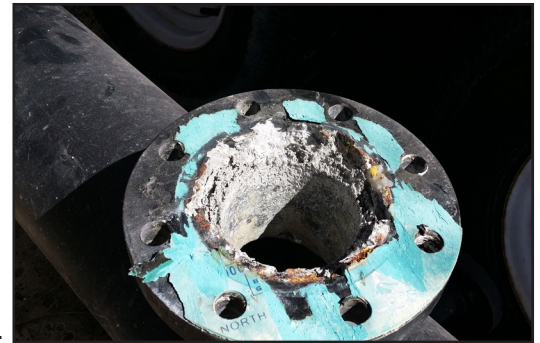
PROBLEM
The flanges and inside of the sea chest tubes had been damaged due to erosion-corrosion wear of saltwater. No protective coating had been previously applied. The sea chest tubes are custom fabricated aluminum for a multi-million dollar yacht.

- PICTURES**
1. Damaged flange face
 2. Erosion-corrosion damage on the inside substrate of the sea chest tube
 3. Forming flange faces using Belzona flange repair kit with Belzona 1111
 4. Application complete. Sea chest tube coated with Belzona 1331
