LIFT STATION RESTORATION WITH BELZONA 1321

CUSTOMER
Florida, USA

APPLICATION DATE
July 2016

APPLICATION SITUATION
One of the city's main lift stations. The city wanted to replace all the corroded cast iron pipe.

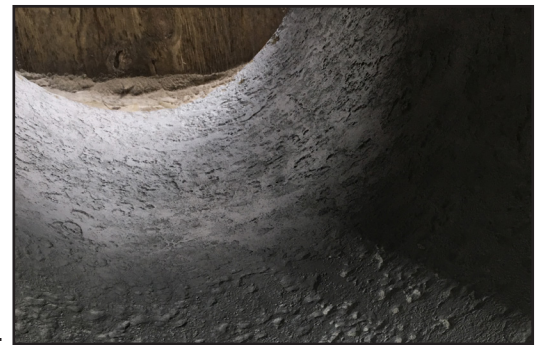
- PICTURES**
1. After grit blasting, the cast iron pipes were very rough.
 2. The GC crew learned how to mix and apply
 3. Belzona products. Three pipes in the back wall, one in the side wall.
 4. One pipe finished.

APPLICATION METHOD
The application was carried out in accordance with CEP-3. First, the pipes were grit blasted with Black Beauty. Belzona 1111 was applied to smooth out the rough cast iron and Belzona 1321 was applied in two coats. The Manufacturer's Instructions for Use were strictly followed.
