BELZONA 1212 SEALS A LEAK ON A WASTEWATER HOLDING TANK

Sub-level wastewater lift station with a concrete holding tank.

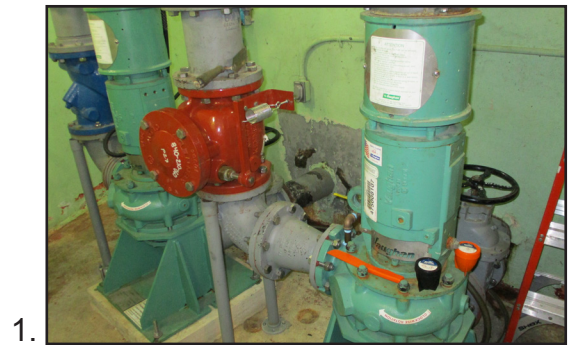
1. Sub-level wastewater lift station pump room
2. Close up view of the leaking areas
3. Belzona 1212 application complete
4. Close up of one area of the application

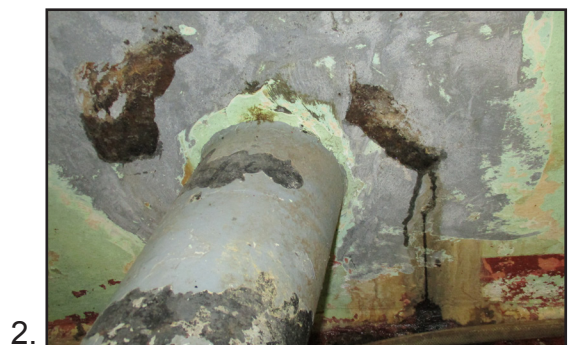
When the pipes were installed through the concrete wall, a grout was used to seal the area around the pipe. After many years of use, the grout began to fail, resulting in raw sewer water leaking into the pump room.

The application was carried out in accordance with TCC-5 Belzona System Leaflet. A grinder was used to remove the paint and the loose and damaged grout around the pipe. The leak was depressurized by lowering the contents of the concrete tank. The crack was explored until it became clear we were into solid concrete and had identified the exact location of the source of the leak. We discovered the raw sewer water was coming through on the bottom right area, but was splitting and coming through the wall there, as well as coming through the wall in the top left area. Both areas were packed full of Belzona 1212 and smoothed over so the Customer could repaint the wall later.
