## BELZONA SUPER METAL RESTORES STRUTS ON A DREDGING VESSEL

**APPLICATION SITUATION**  
Struts supporting propulsion system and housing cutlass bearings on 200 foot dredging vessel.

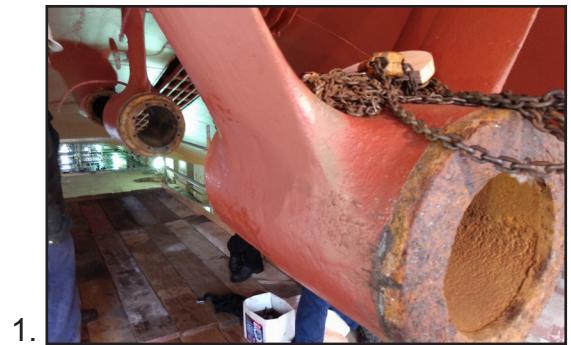
**PROBLEM**  
The internals of all 4 struts had suffered erosion and corrosion from seawater and needed to be restored.

- PICTURES**
1. 2 of 4 struts that needed restoration
  2. A clean, solid, roughened substrate
  3. Surface built up with Belzona 1111
  4. Completed application ready for cutlass bearings
