BELZONA SAVES FISHING BOAT COOLING-WATER CIRCULATING PUMP

Cooling-water circulating pump, totally damaged by cavitation.

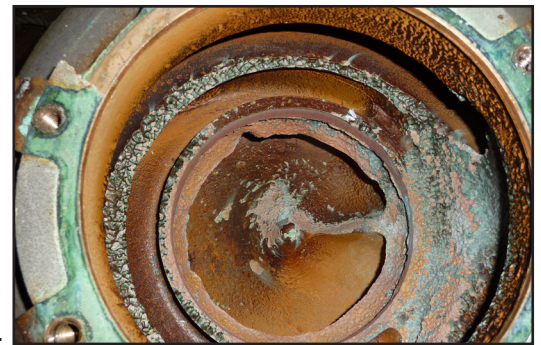
1. Damaged pump casing.
2. Pump repaired and coated.
3. Damaged impeller.
4. Impeller repaired and coated with Belzona.

Application was carried out in accordance with Belzona system leaflet CEP-3. The pump and impeller prepared by gritblasting. Damage in the pump and impeller was rebuilt with Belzona 1311 and coated with Belzona 1321. The impeller was balanced and pump rebuilt with original parts.
