BELZONA PREVENTS WATER PENETRATION INTO A DATA STORAGE FACILITY

APPLICATION SITUATION
Steps at the entrance to a financial building.

PROBLEM
Spider cracks compromising the integrity of the staircase and allowing water to penetrate into the building's data center underground.

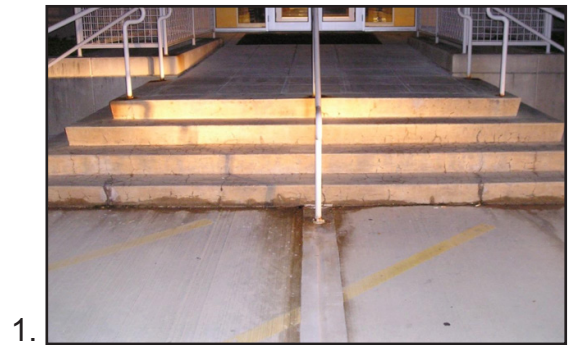
- PICTURES**
1. Showing Damage
 2. After powerwashing
 3. Completed application; the cracks filled, and the steps re-surfaced with Belzona 4111 for a long-term protection
