DATA CENTER'S ENGINEERING ROOM WATERPROOFED WITH BELZONA

Floor in an engineering room located in a penthouse of a building.

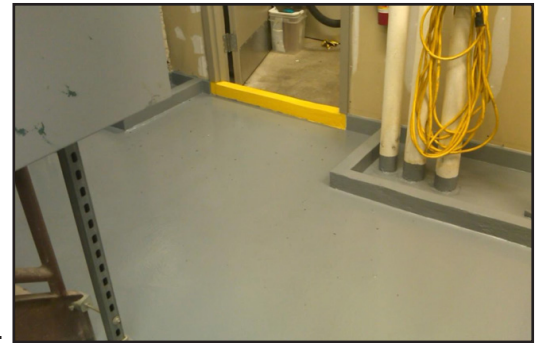
1. Threshold built with Belzona 4131 and made "safety" visible with Belzona 4411.
2. Curbs around the piping built with Belzona 4131. The floor is coated with Belzona 5231
3. Application is completed

Belzona materials were used to install new curbs and thresholds and to provide a protective sealant to the flooring. Belzona 3121 was used to seal the areas between piping and the floor. The threshold at the door and curbs around the piping were built with Belzona 4131. To avoid a trip hazard and to ensure safety the thresholds were coated with Belzona 4411 Yellow. Then, the entire floor was coated with Belzona 5231 for chemical and water protection as well as to provide a non-slip and easy-to-clean finish. No more leaks jeopardizing the critical facility below.
