HOSPITAL'S ENGINEERING ROOM EXPANSION JOINTS WATERPROOFED WITH BELZONA

APPLICATION SITUATION
Expansion joints in an engineering room of a hospital.

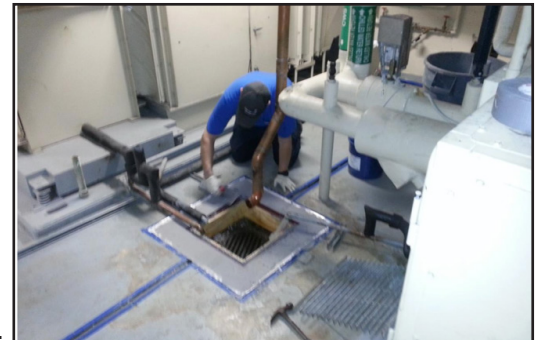
- PICTURES**
1. Concrete restoration with Belzona 4111
 2. New joint installation with Belzona 2221

APPLICATION METHOD
First, the existing joint material was removed, and the concrete was restored with Belzona 4111. A new joint was installed using a foam backer rod and Belzona 2221.
