BELZONA SUPERWRAP REPAIRS CRUDE OIL PIPELINE

The crude oil pipeline is a critical part of the refinery and could not be shut down.

Corrosion Under Insulation had created corrosion scabs to form at the underside of the pipe. Blasting of these scabs was not allowed.

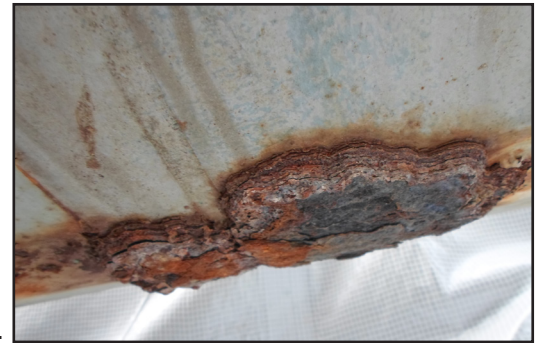
1. Corrosion scab on underside of pipe.
2. Blasting of the pipeline.
3. Application of SuperWrap II.
4. Finished application.
