BELZONA REPAIRS AND PROTECTS THE FLOOR OF A BATTERY TREATMENT PLANT

Chemical Plant, France

Concrete floor of a battery treatment plant.

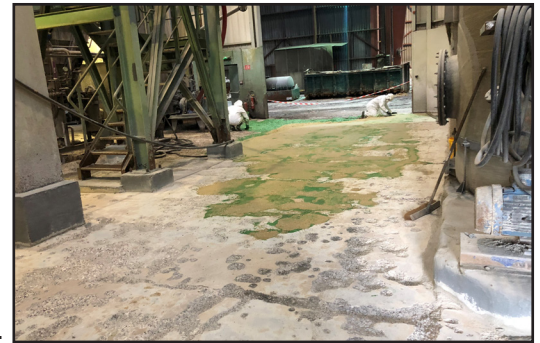
The concrete floor of this battery treatment plant was badly damaged by the acid from the batteries. Around 400 tonnes of batteries are treated each day in this plant and the acid attacked the concrete leading to severe pitting up to 40cm deep.

1. Before application.
2. Before application.
3. After resurfacing with Belzona 4151.
4. Final application after protection with Belzona 4311.
