BELZONA EXPANDS THE LIFE OF EXPANSION JOINTS

Kingdom of Saudi Arabia

2013

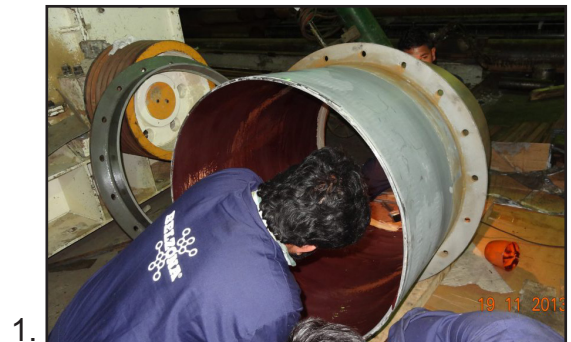
1. Lining in action
2. Lining completed
3. Expansion joint application
4. Application finished

The application was carried out in accordance with modified Belzona Know-How System Leaflet MPT–06. Rebuilding and machining of sealing faces was carried out with Belzona 4301. Internal coating/non sealing faces were coated with Belzona 4311.
