BELZONA SHAFT REPAIR BY FORMING TECHNIQUE AT A PAPER MILL

Shaft on a vacuum pump at a paper mill.

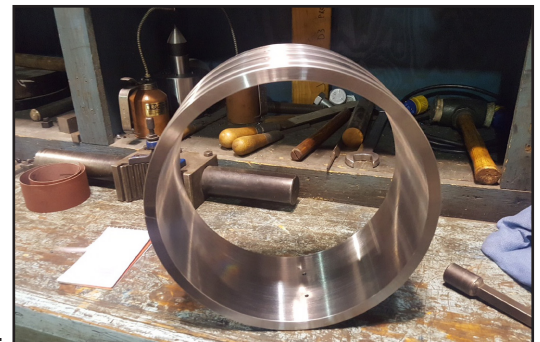
1. Former that was made and used.
2. Damaged shaft.
3. Shaft prepared/surface roughened up.
4. Finished application.

This application was carried out in accordance with a modified version of Belzona Know-How System Leaflet MPT-2 (Shaft Repair by Forming Technique). The area was prepared by using a small disk grinder which was used to cut grooves into the shaft then was roughened by using a bur bit. The shaft was thoroughly cleaned using Belzona 9111. Belzona 9411 was placed on the former and on the shaft where product was not wanted. Belzona 1111 was placed on the shaft and on the former and squeezed together. After a few hours the former was removed and the shaft was dressed up making sure to remove any unwanted Belzona 1111.

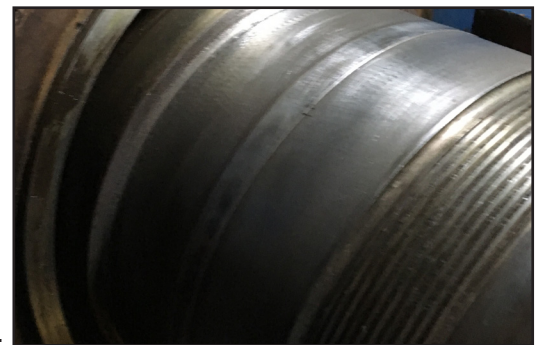
2.

Bearings spun on shaft taking with it an estimated .080 or 80 thousandths from the shaft.
