BELZONA REPAIRS A CAR ENGINE CASING

Cracked Engine Casing on a government vehicle.

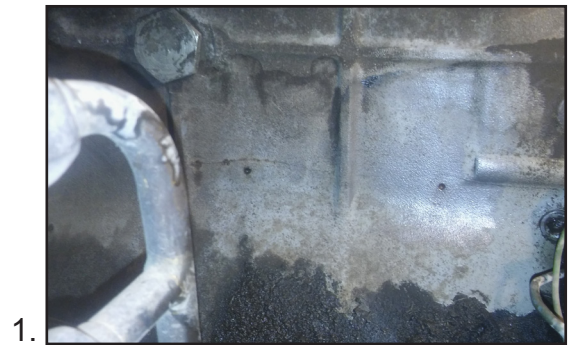
The freezing winter temperatures had caused excessive movement and a crack in the engine casing.

1. Cracked engine.
2. Crack detection.
3. Surface preparation.
4. Belzona 1111 application with reinforcement tape.
