## BELZONA 4311 PROTECTS A NITRIC ACID LOADING AREA AT A CHEMICAL PLANT

Chemical Plant, Florida, USA

Nitric acid loading area at a chemical plant.

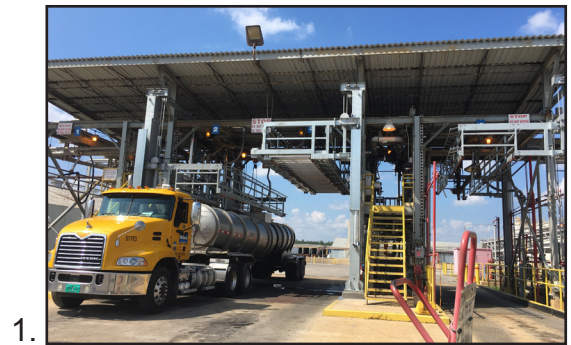
1. Trucks unloading nitric acid.
2. Belzona 4311 applied.
3. Belzona 4311 applied.
4. Belzona 4311 applied.
