## BELZONA SACKS AN NFL SIZED PROBLEM

Sports Arena, Northeast USA

Floor joints in the seating areas of the arena. The Customer requested a sample application to potentially repair 32 problem areas measuring 11' in length each.

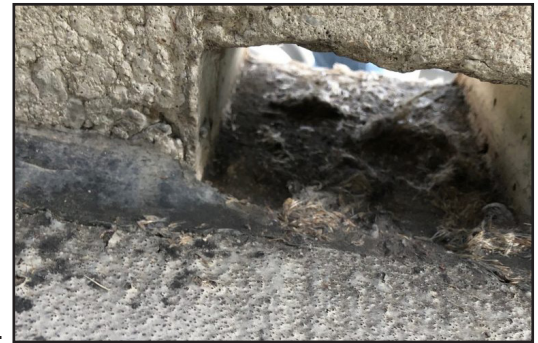
Poorly lined floor joints allowed water to seep through to lower seating levels of the arena. This water leakage resulted in a drip/slip hazard, concrete staining, corrosion, and damage to the beam and concrete structure below the luxury box suites. A walk-through revealed 32 problem areas measuring 11 feet in length each, causing leakages throughout the stadium. The lining replaced by Belzona was a failed flexible caulk.

1. Failed joint and drain.
2. Surface preparation in progress.
3. Application of Belzona elastomeric system.
4. Complete application.
