BELZONA EXTENDS THE LIFE OF A SEAWATER PIPE

Gulf of Mexico, USA

November 2016

Interior of a seawater piping at an oil producing facility. They were one of the first companies to embrace the new technology of Belzona 1331.

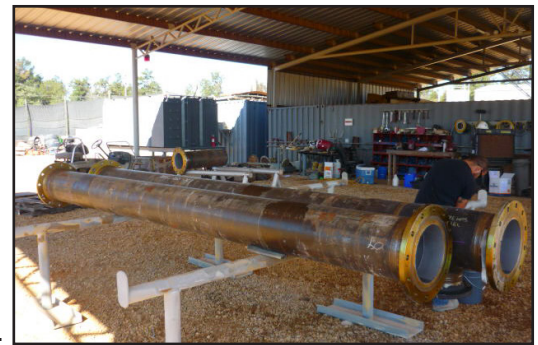
1. Pipes after abrasive blasting.
2. Surfaces are degreased prior to application.
3. Belzona 1331 internal lining.
4. Complete application.

These 12" sections of pipe were internally lined by brush and roller due to spin-spray equipment not available. Belzona 1331 was installed in four thin coats with the pipe orientation changing four times.
