BELZONA REBUILDS A DAMAGED BEARING HOUSING

A bearing housing.

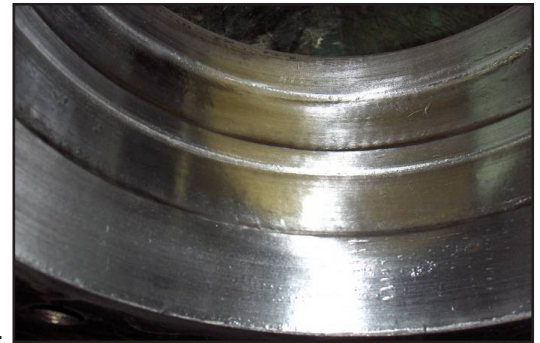
Bearing had seized due to the lack of lubrication. This caused it to spin loose and erode away the metal on the bottom of the housing

1. The bearing housing had worn oversize because of lacking of lubrication.
2. The eroded area was prepared by using a Bristle Blaster The worn area was rebuilt with a thin layer of Belzona 1111.
3. A new housing was pressed into place and the Belzona material allowed to set up before the component was reinstalled.

The application was carried out in accordance with Belzona Know-How System Leaflet MPT-7. The damaged areas were cleaned using a bristle blaster. Then the repair areas were rebuilt with Belzona 1111. A new housing were inserted into place.
