BELZONA DELIVERS ACCURACY TO A WEIGH SCALE PLATFORM

The mating surfaces between sections of a weigh scale platform.

The scale consists of three separate sections bolted together; the machined surfaces where the sections connect were corroded and could no longer provide the solid connection required for accuracy.

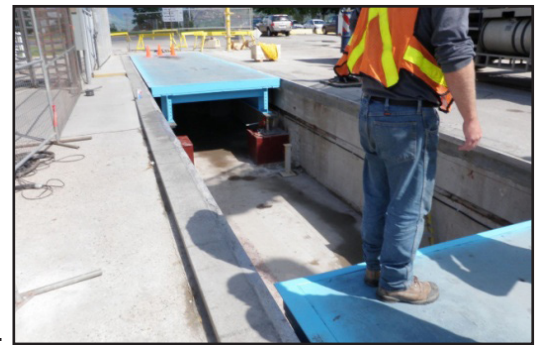
1. The mating surfaces between sections of the weigh scale platform were badly pitted.
2. The center section of the scale had to be lowered into this gap with only 1/4 inches of clearance either end.
3. The center section was in place and bolted to the ends with Belzona 1121.

The application was carried out in accordance with a modified version of Belzona Know-How System Leaflet GSS-4. The mating surfaces between sections of the weigh scale platform were badly pitted. They were originally coated with a blue paint, which was removed prior to application. The center section of the scale had to be lowered into this gap with only 1/4" of clearance on either end. The center section was in place and bolted to the ends with Belzona 1121 providing a positive contact between the mating surfaces to ensure accuracy.

The corroded surfaces were prepared, then Belzona 1121 was applied between the connectors, prior to bolting to fill any voids caused by corrosion and provided full contact irregular shim between the surfaces. The extended set up time of Belzona 1121 allowed the delicate assembly to proceed without haste.
