## BELZONA CUTS DOWN A CONCRETE SHIMMING APPLICATION TIME FROM 45 TO 7 DAYS

Paper Mill, Brazil

August 2017

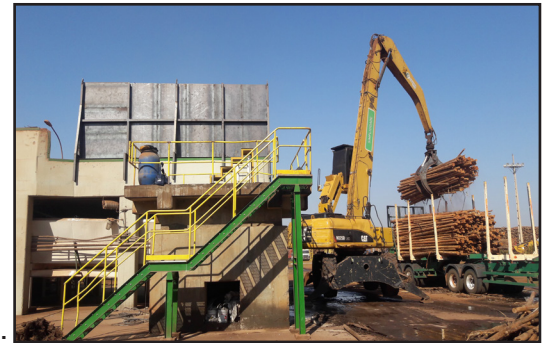
1. View of the crane
2. Concrete foundation before
3. Application in progress including new anchor holes being drilled
4. Completed application

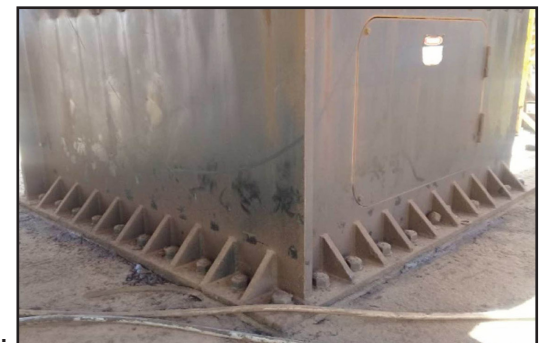
2.

Due to constant movement and vibration created between the skid and the concrete foundation, the heads of the bolts holding the base down started to break off.
