INTERNAL REPAIR AND PROTECTION OF A SPLIT CASE PUMP WITH BELZONA 1341

Internal surface of a splitting-case pump.

The internal surface of this splitting-case pump was badly damaged by corrosion and needed to be rebuilt and protected.

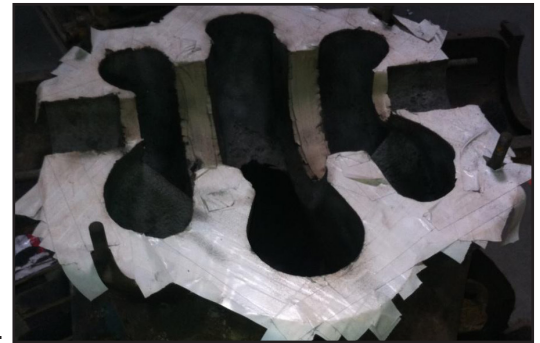
1. Before the application.
2. Showing the damage on the internal part of the pump.
3. First coat of Belzona 1341 in grey.
4. Second coat of Belzona 1341 in blue.

The substrate was first grit blasted and cleaned with acetone. Then the displacement nose was rebuilt using Belzona 1111. Finally, the whole internal surface was protected with 2 coats of Belzona 1341. The application was carried out in accordance with Belzona system leaflet CEP-3.
