NO MORE LEAKS ON A COOLING TOWER WITH BELZONA

Water pipe on a cooling tower.

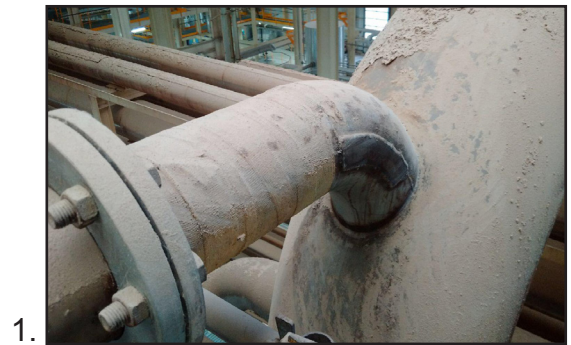
This water pipe was leaking due to antibacterial agents present in the water damaging the substrate and causing corrosion pitting.

1. Before application.
2. After surface preparation.
3. After application of Belzona 1111 with reinforcement tape.
4. Final application.
