BELZONA REPAIRS AND RESTORES PUMP

Metallurgy Company, Slovakia

This was a complete overhaul of the pump. Several years of operation (cooling water with small steel particles) resulted in a damaged stator, rotor and bearings.

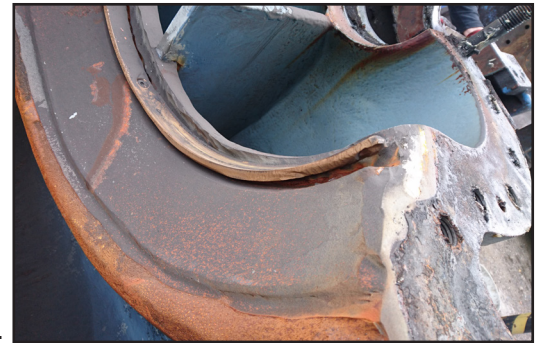
Erosion and Corrosion damage

1. Destroyed stator.
2. Pump grit blasted.
3. Pump casing after reconstruction.
4. Ready for service.
