## BELZONA REMEDIES DAMAGE CAUSED BY A BROKEN PISTON ROD

**APPLICATION SITUATION**  
A casing of an engine.

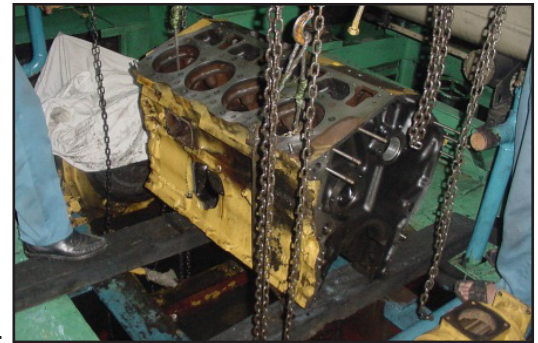
1. Engine block removed and hoisted into position.
2. Close up of the defect.
3. Plate bonding with Belzona 1111.
4. Completed application.
