## PAPER MILL PRESS ROLL SAVED FROM REPLACEMENT BY BELZONA

Solids Handling Machinery - paper mill press roll.

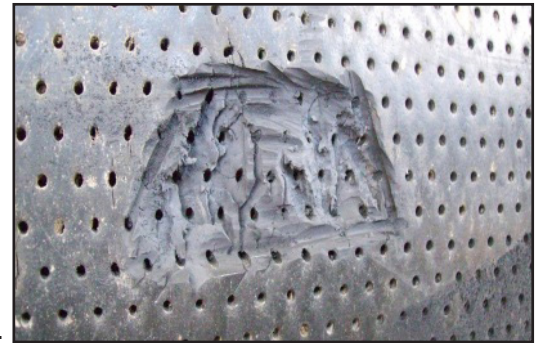
1.

Trapped material under the press roll caused scoring damage to the surface.
