ROLLER SHAFT RE-BUILT WITH BELZONA

Steel mill roller shaft problem.

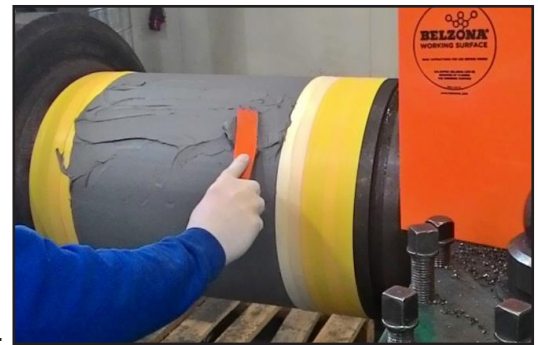
1. Belzona 1111 used to build the profile up.
2. Applied Belzona material being machined back on the lathe.
3. Completed repair.

The prepared surface was cleaned using Belzona 9111. The profile was rebuilt with Belzona 1111, then machined back to the correct diameter using a lathe.
